Olive Downs Coking Coal Project

Additional Information to the
Environmental Impact Statement

**Additional Information on
the Rehabilitation Strategy**

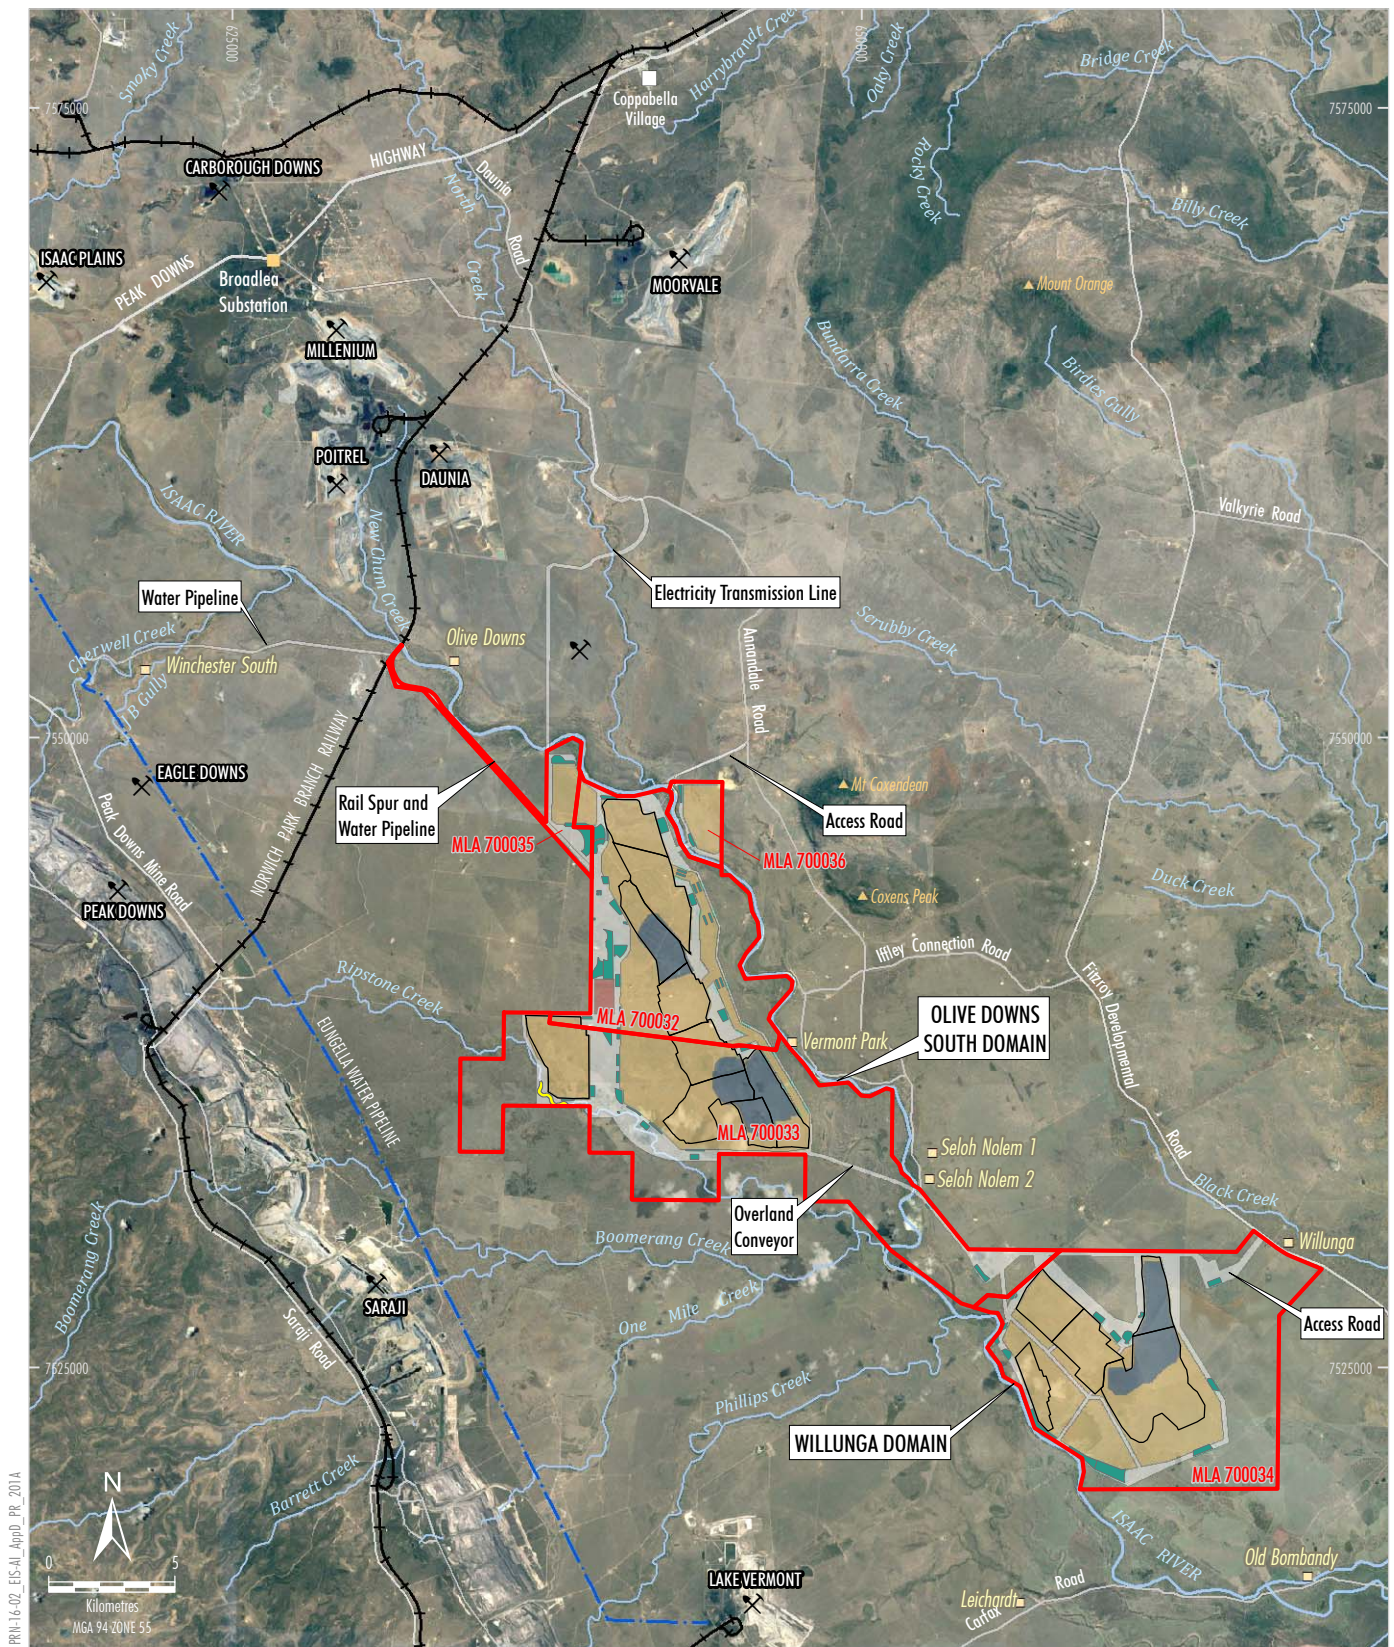
Figure 1

The revised Project rehabilitation domains are shown on Figure 1.

OLIVE DOWNS COKING COAL PROJECT Rehabilitation Domains

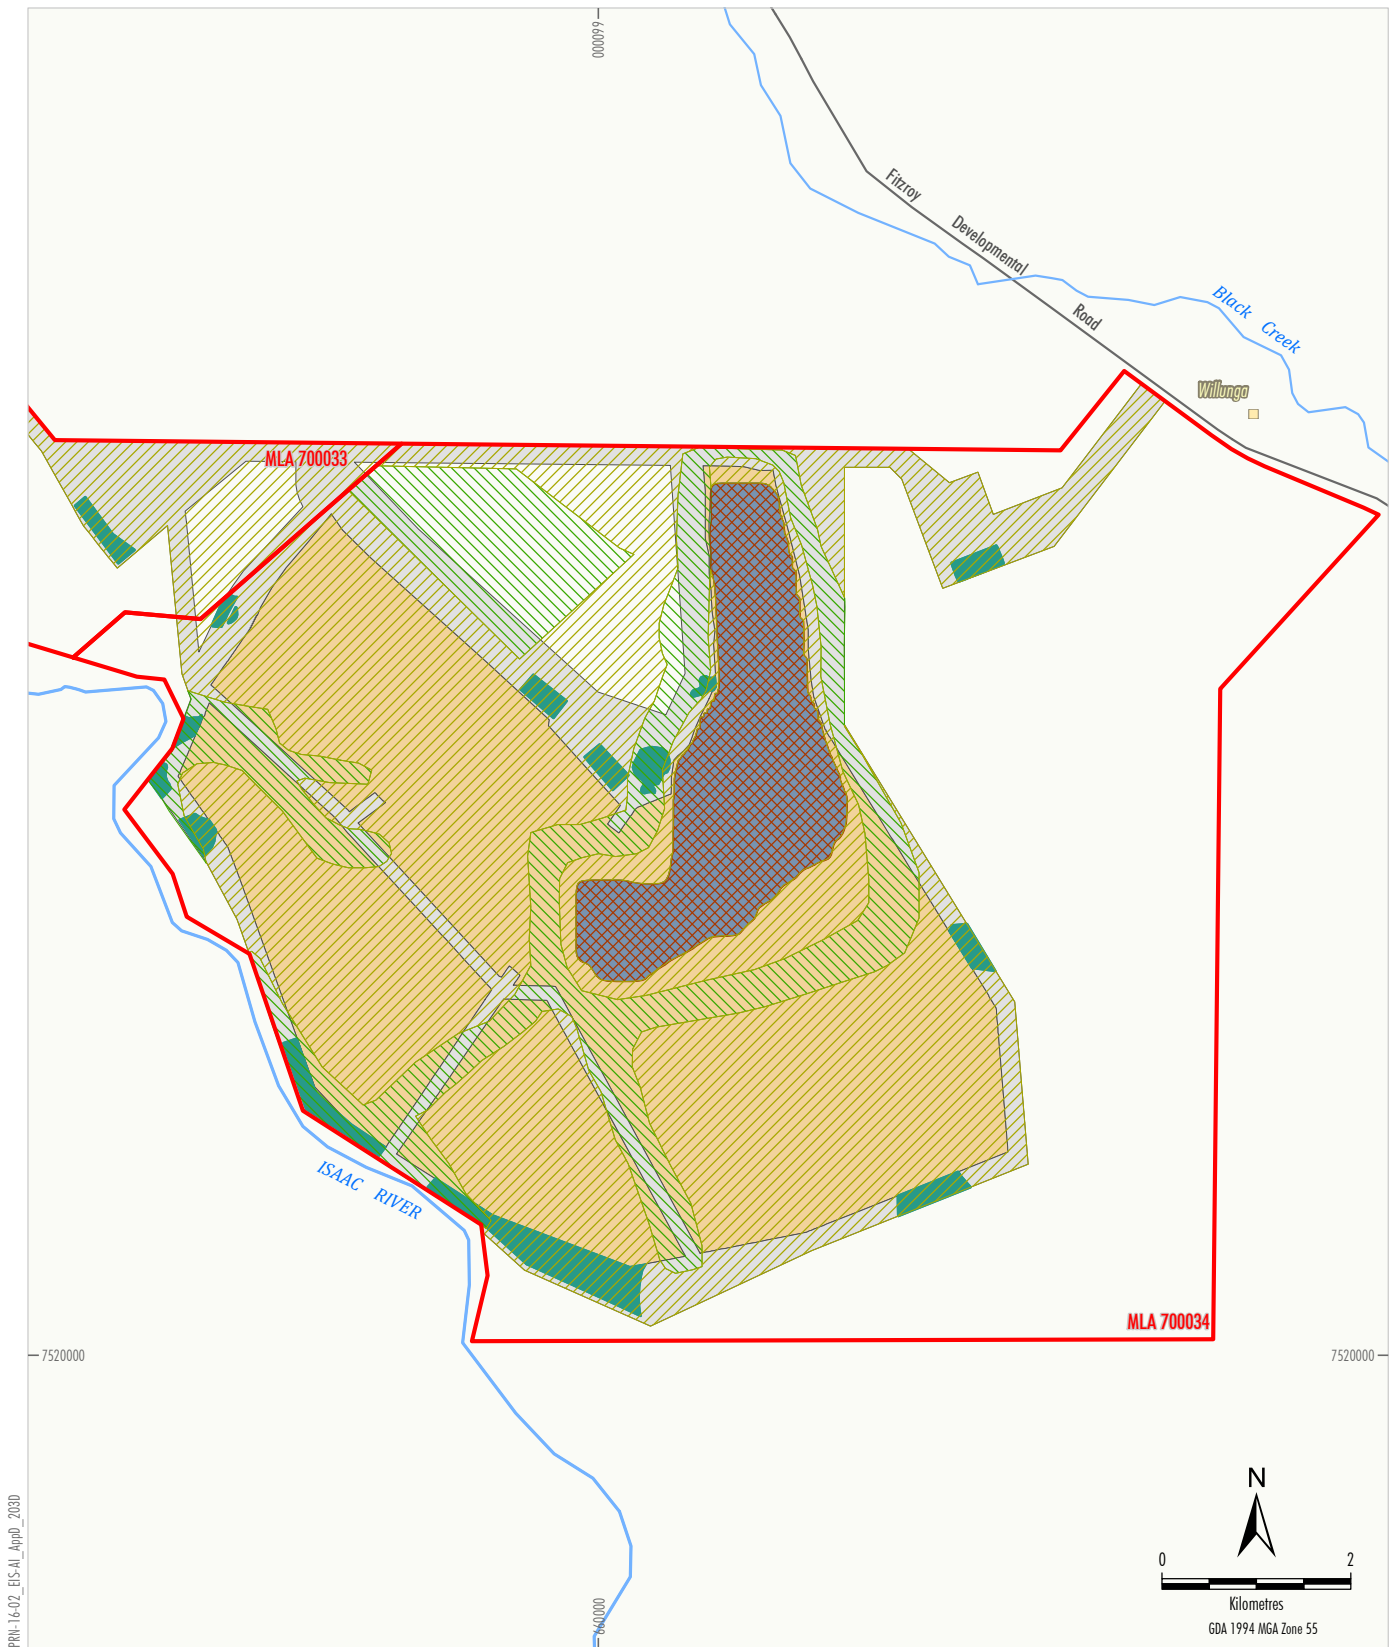
Figure 2b

OLIVE DOWNS COKING COAL PROJECT
Conceptual Post-mining Land Use
Willunga Domain

An illustration of the conceptual post-mining land use across the Project final landform is presented on Figure 2.

Areas of the Project site would be rehabilitated to an agriculture (low intensity cattle grazing) post-mining land use (Figure 2 and Table 2). No agriculture (cropping) or forestry land uses are proposed.

Areas of the Project site would be rehabilitated to a native vegetation (woodland) post-mining land use (Figure 2 and Table 2).

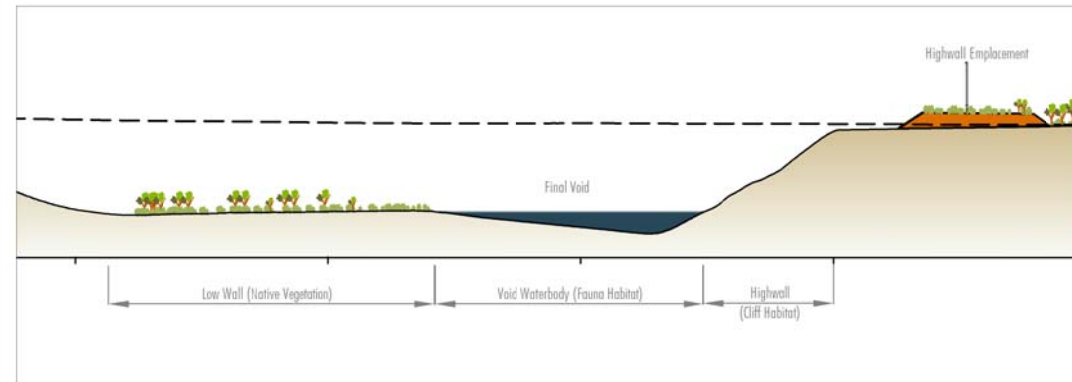
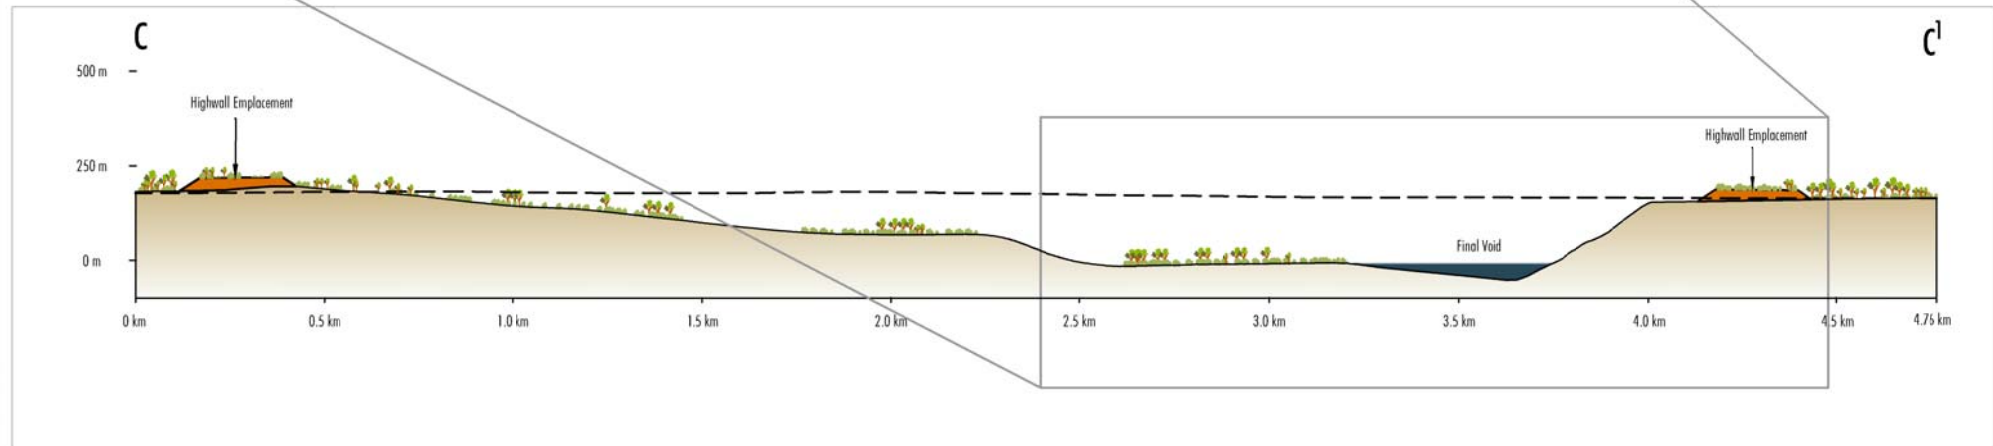
Figure 3

The final voids would comprise of low wall, highwall and a void water body landform components. Pembroke has investigated the likelihood that the final void would provide suitable native fauna habitat (Table 3). The final voids would provide suitable habitat for a range of native fauna, including species recorded within the Project site by DPM Envirosciences (2018a) such as the Strip-faced Dunnart (*Sminthopsis macroura*), Hoary Wattled Bat (*Chalinolobus nigrogriseus*) and Australian Grey Teal (*Anas gracilis*) (Table 3).

The final voids at the Project would be rehabilitated to a fauna habitat post-mining land use (Figures 2 and 3 and Table 2).

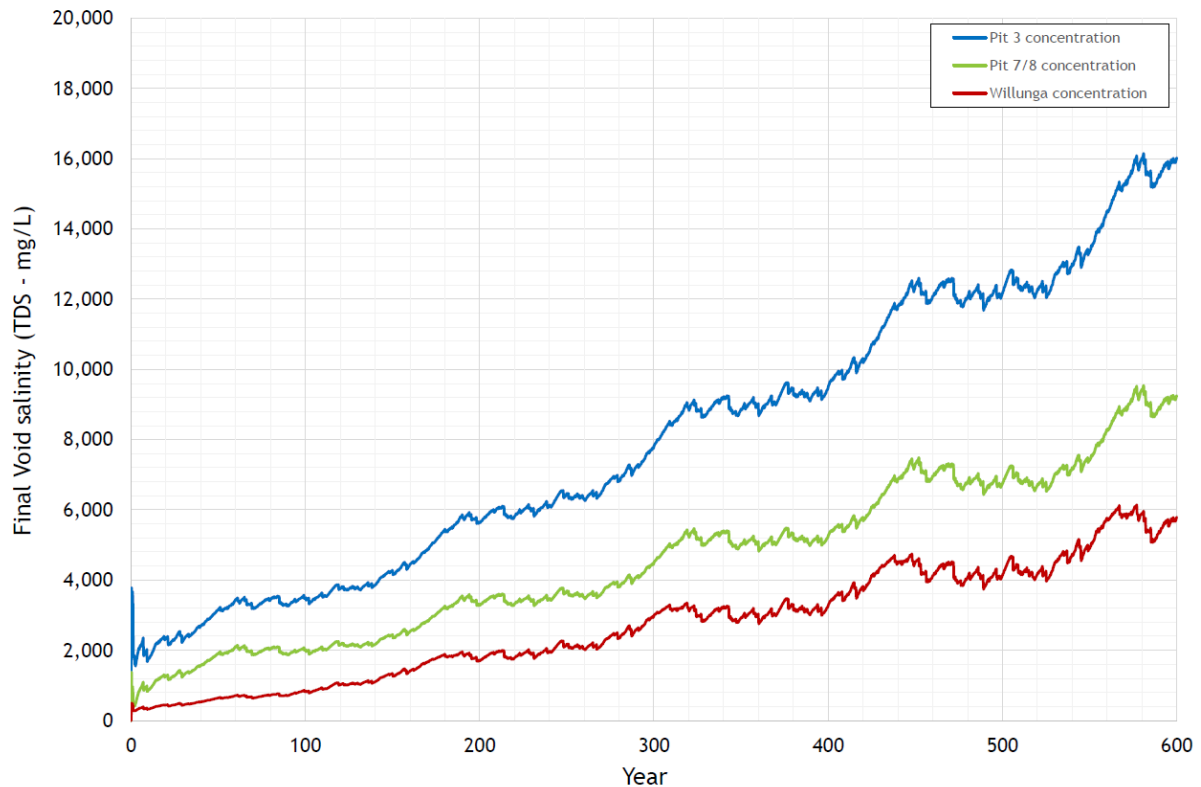
Chart 1
Revised Final Void Salinity Balance

The final void salinity balance presented in the draft EIS has been revised incorporating the commitment to remove basement coal. The simulated long-term salinity levels in the final voids based on the revised modelling are shown in Chart 1. The results indicate that the rate of salinity increase is significantly lower if all coal is removed from the final void floor at the end of mining. For example, under the revised balance, the salinity of the ODS7/8 and WIL5 final void water bodies are predicted to remain brackish (i.e. <5,000 mg/L TDS) for approximately 300 to 550 years. The ODS3 final void water body is predicted to remain brackish for approximately 150 to 200 years.

As described in Table 3, water bodies with salinity levels <4,000 mg/L TDS are able to provide habitat for a variety of freshwater aquatic plants and invertebrates. Some ducks, such as the Australian Grey Teal (recorded on-site as part of the EIS Ecology Assessment [DPM, 2018a]) are known to use permanent brackish and saline habitats.

Although the final void water bodies are not predicted to reach hypersaline conditions (i.e. >35,000 mg/L TDS) for at least the modelling period (i.e. 600 years), it is recognised that some ducks are also known to live in hypersaline environments by also drinking freshwater from elsewhere (Hart et al, 1991). Halophytic plants grow around the edges of water bodies under hypersaline conditions (after Hart et al, 1991).

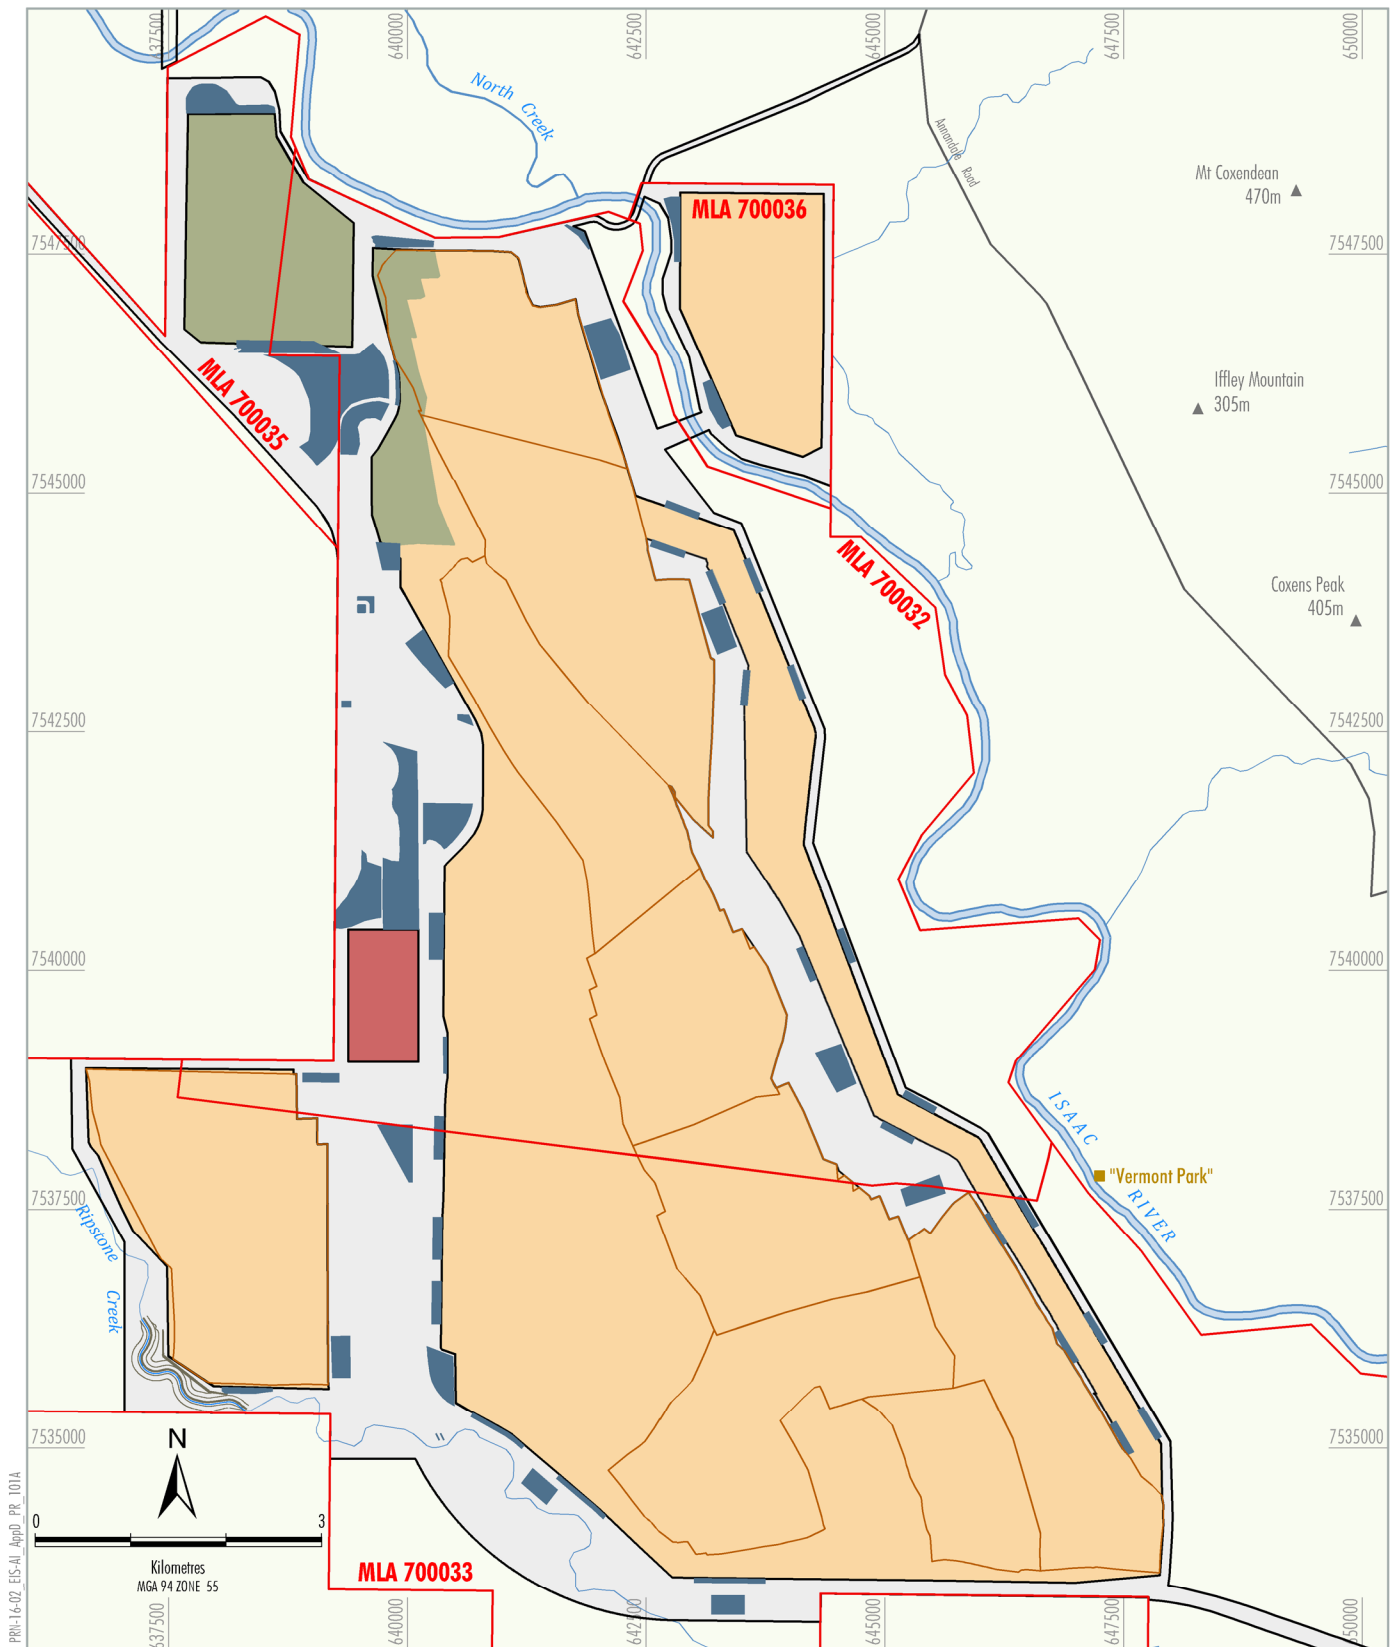
Figure 1

PEMBROKE
 OLIVE DOWNS COKING COAL PROJECT
 Olive Downs South Domain
 Progressive Rehabilitation - 2027

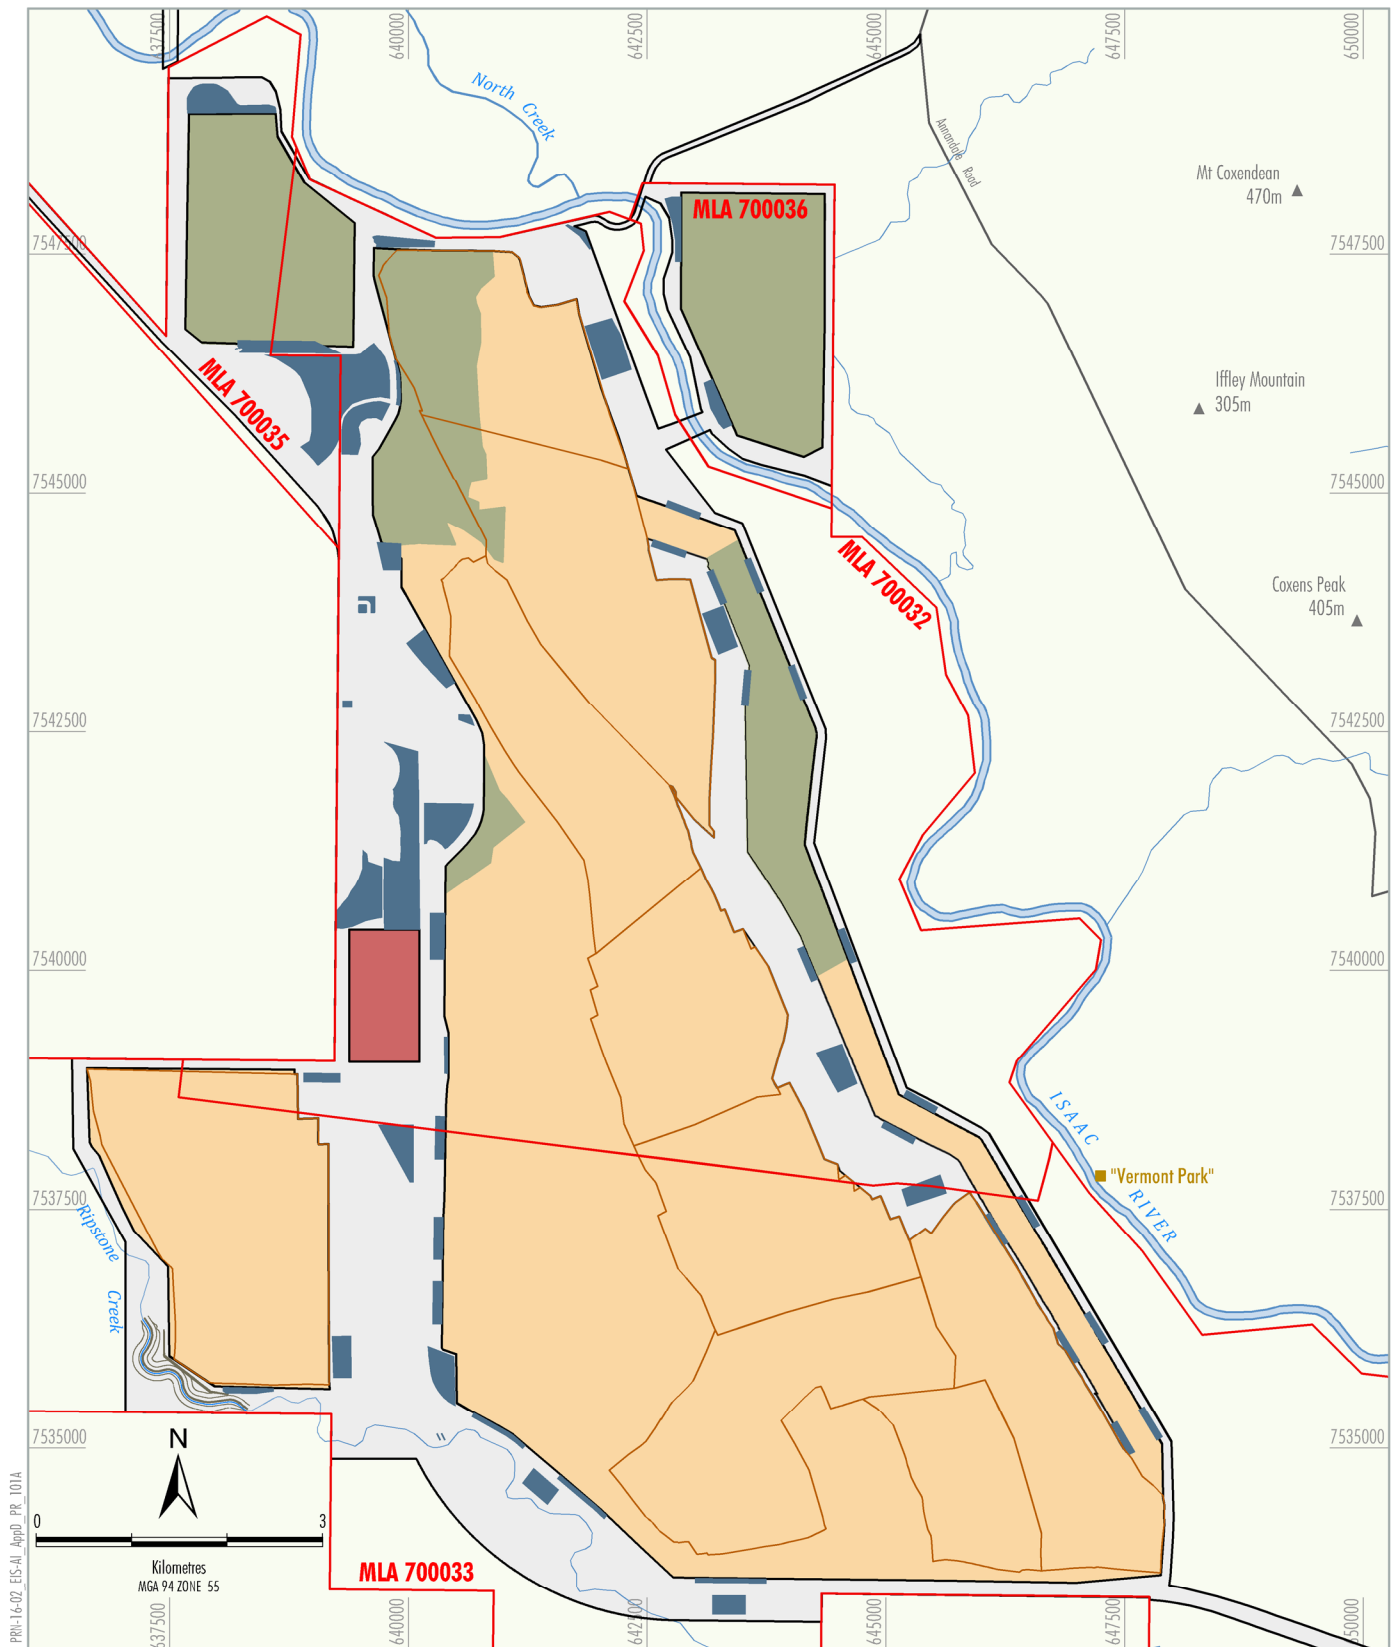
Figure 2

OLIVE DOWNS COKING COAL PROJECT
Olive Downs South Domain
Progressive Rehabilitation - 2030

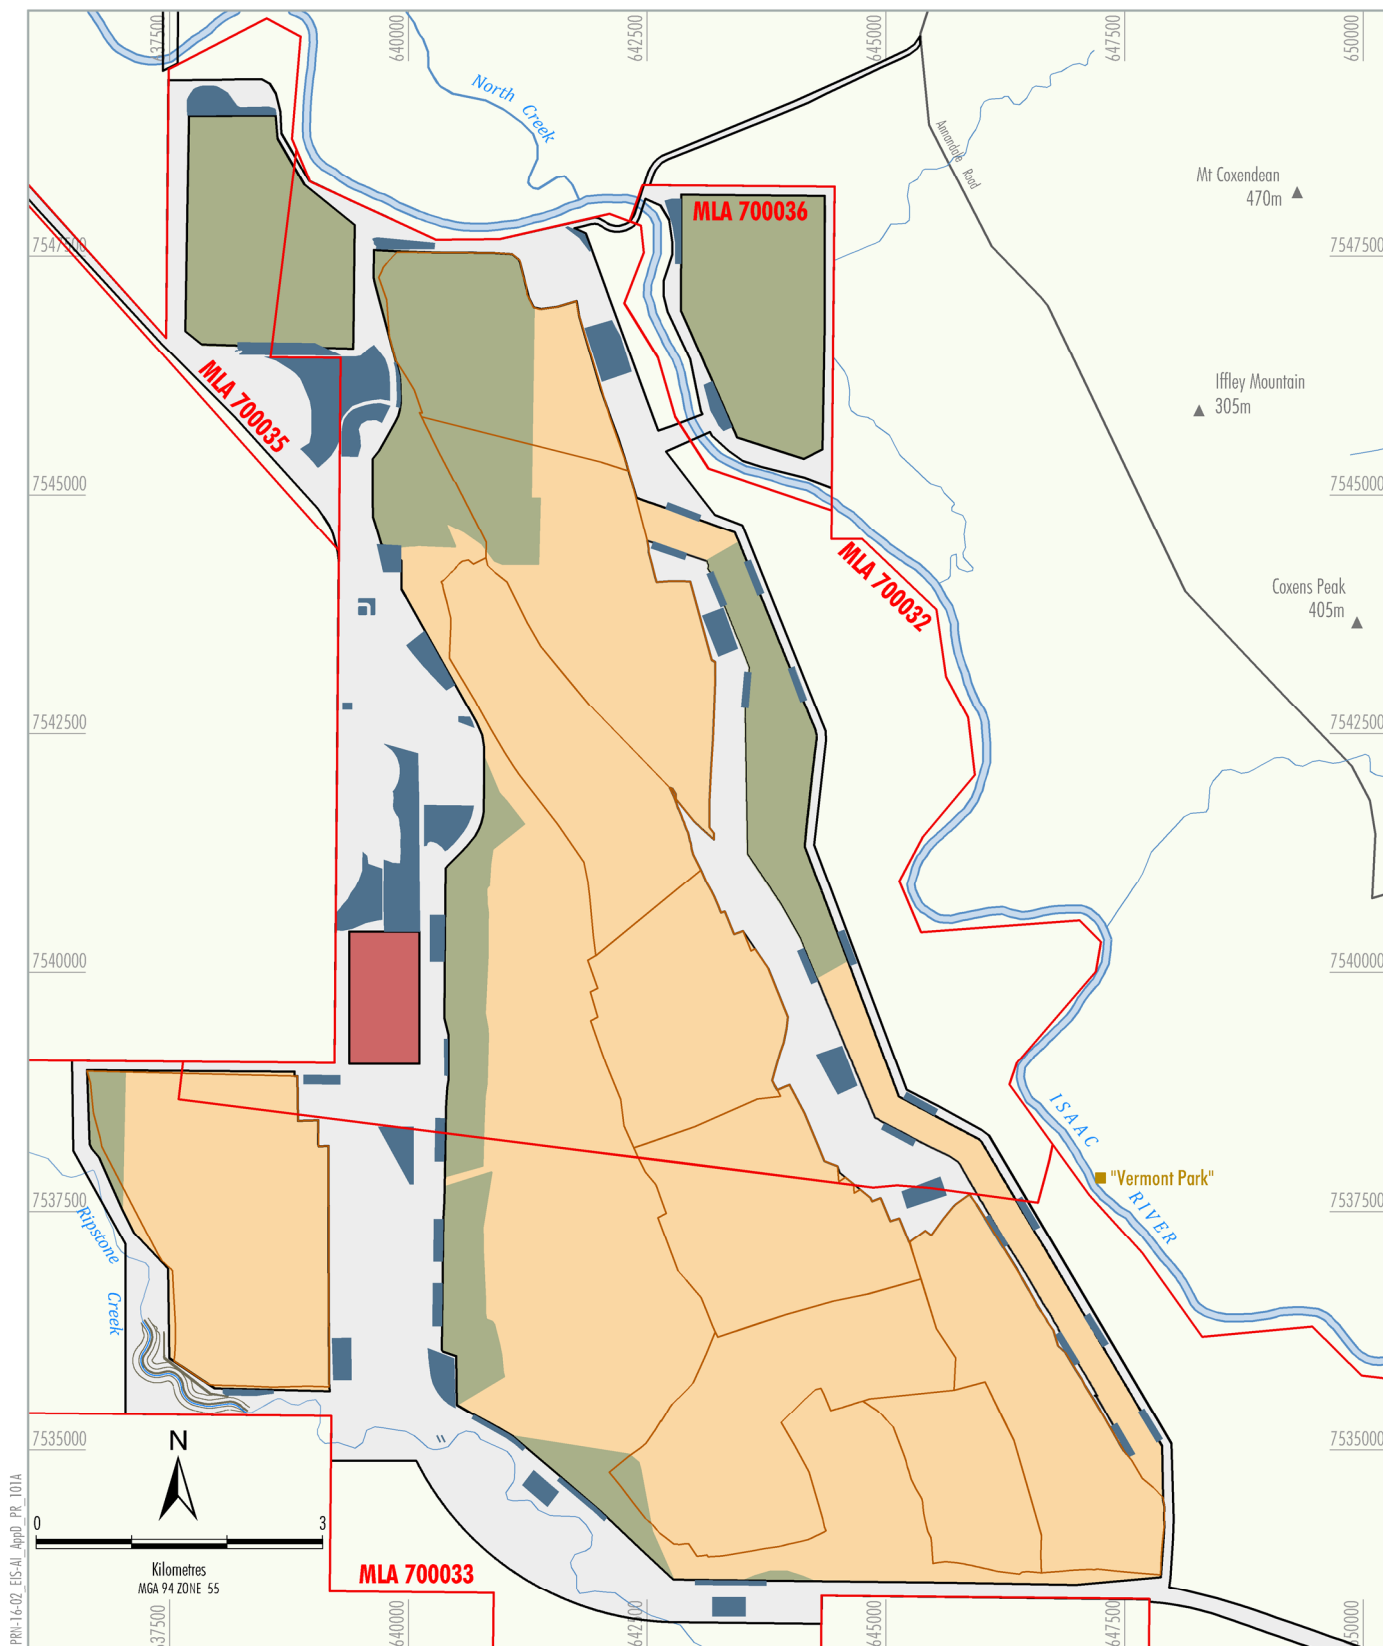
Figure 3

Olive Downs South Domain
Progressive Rehabilitation - 2035

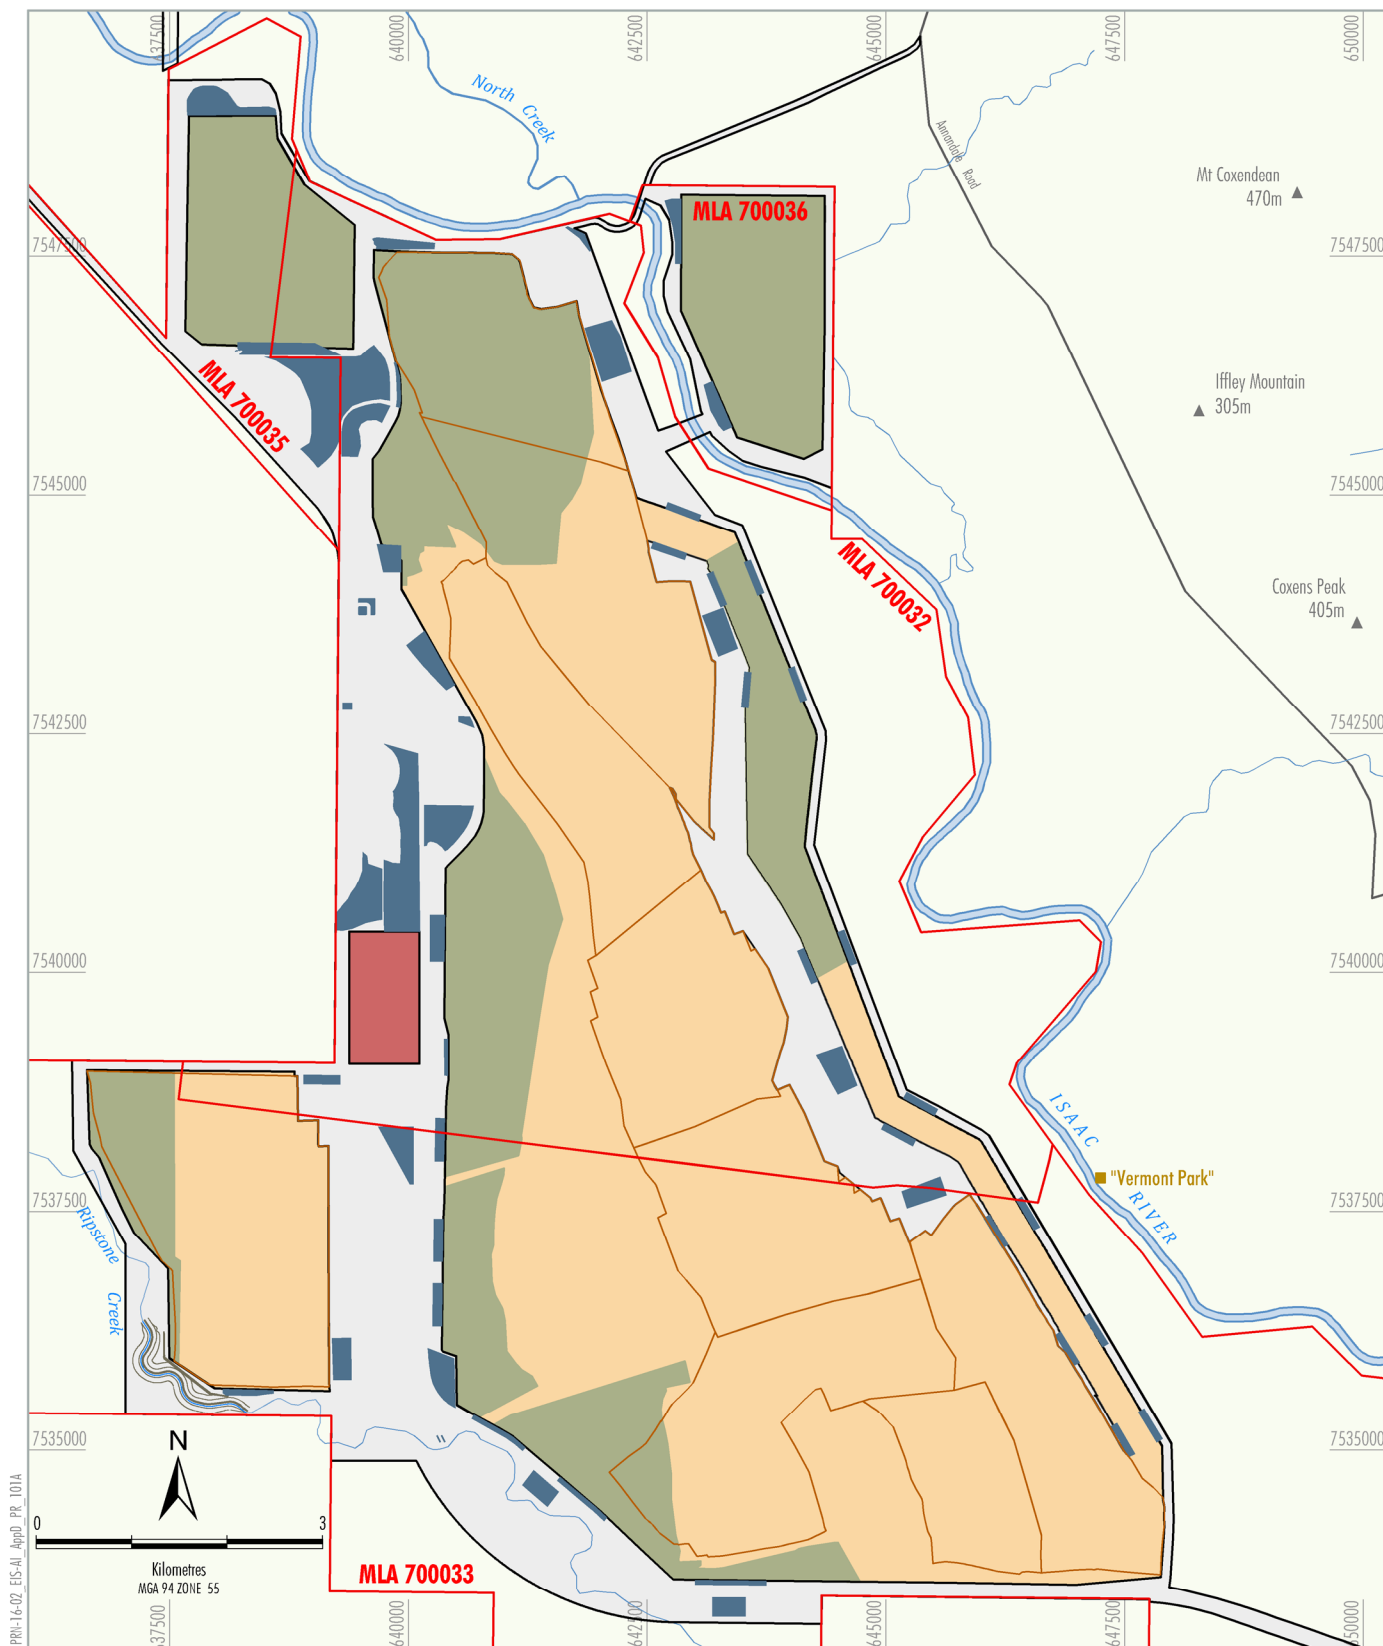
Figure 4

Olive Downs South Domain
Progressive Rehabilitation - 2040

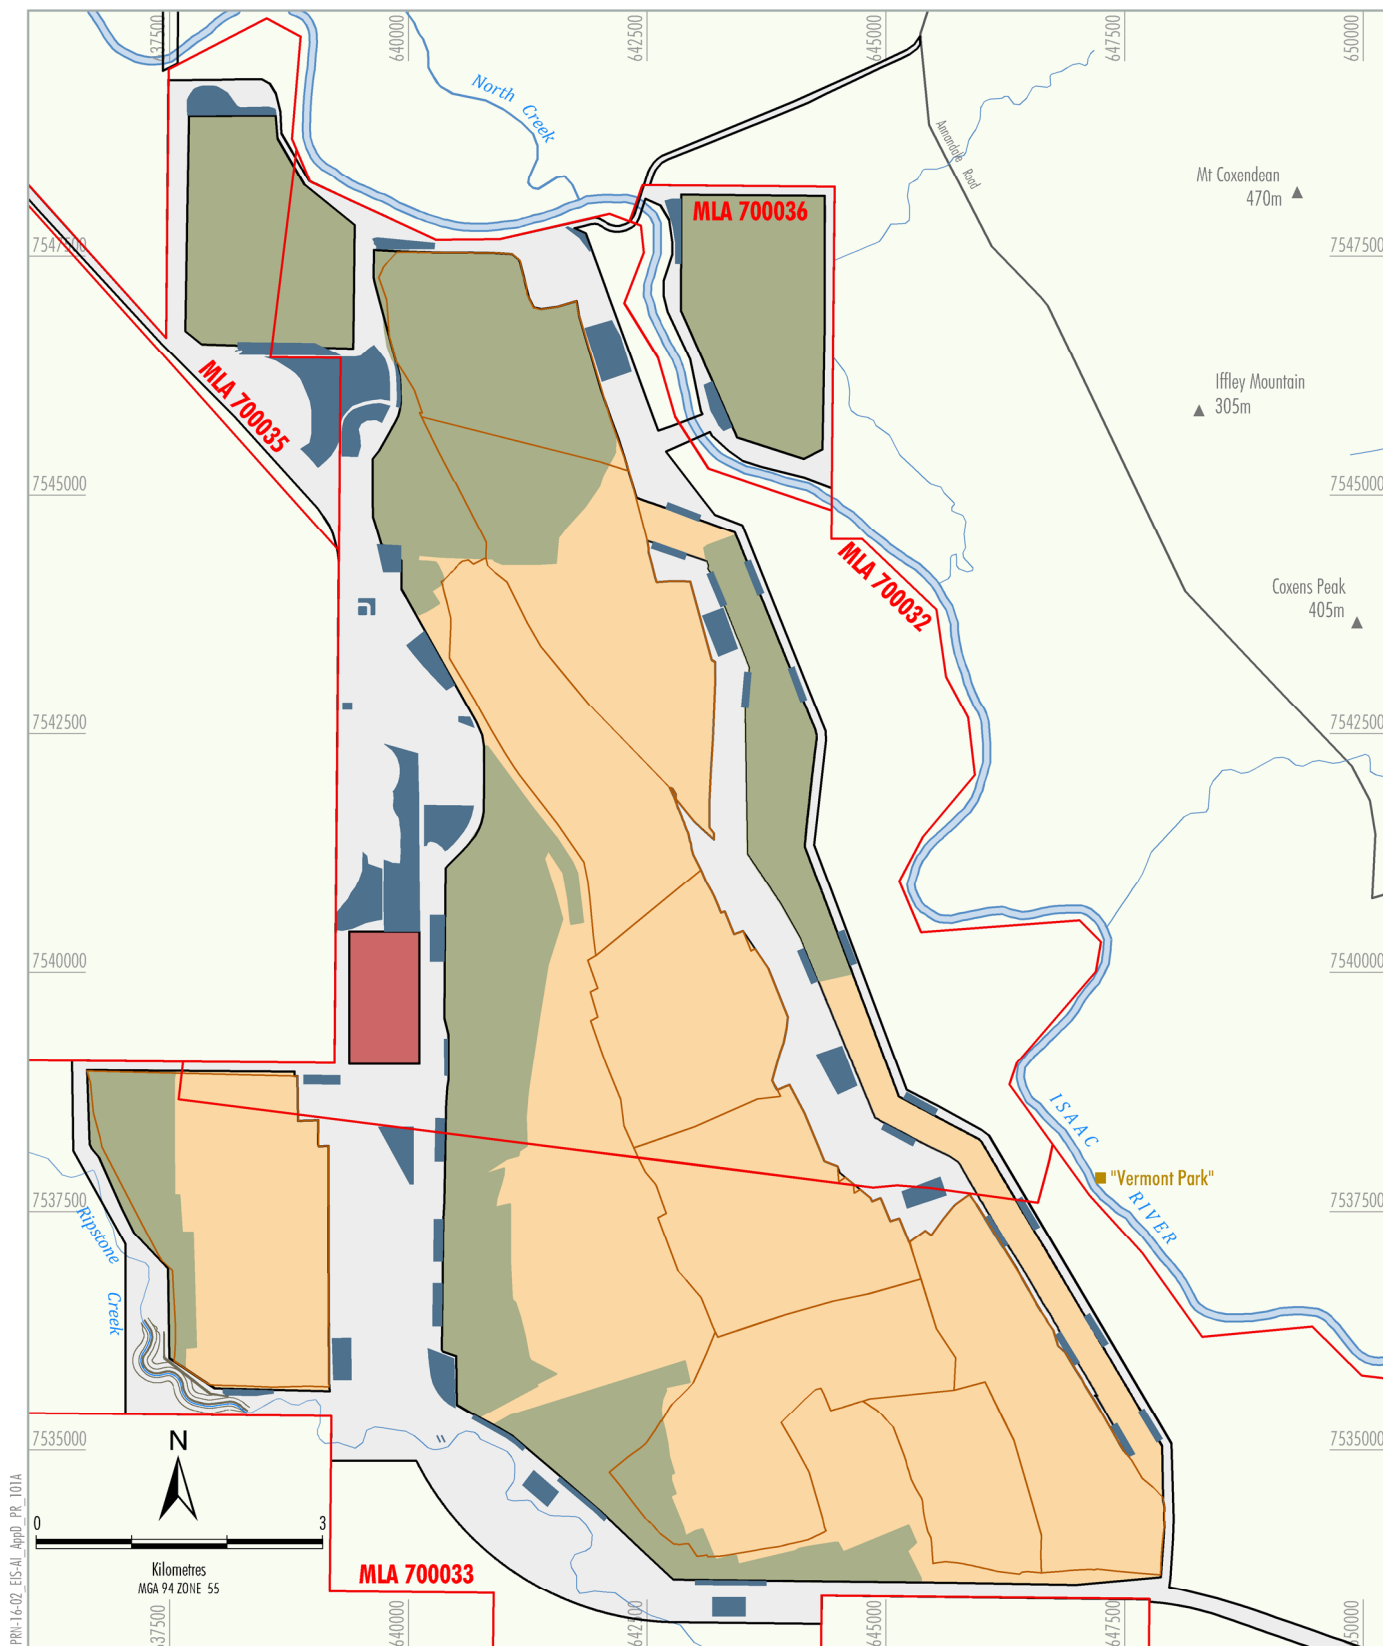
Figure 5

Olive Downs South Domain
Progressive Rehabilitation - 2045

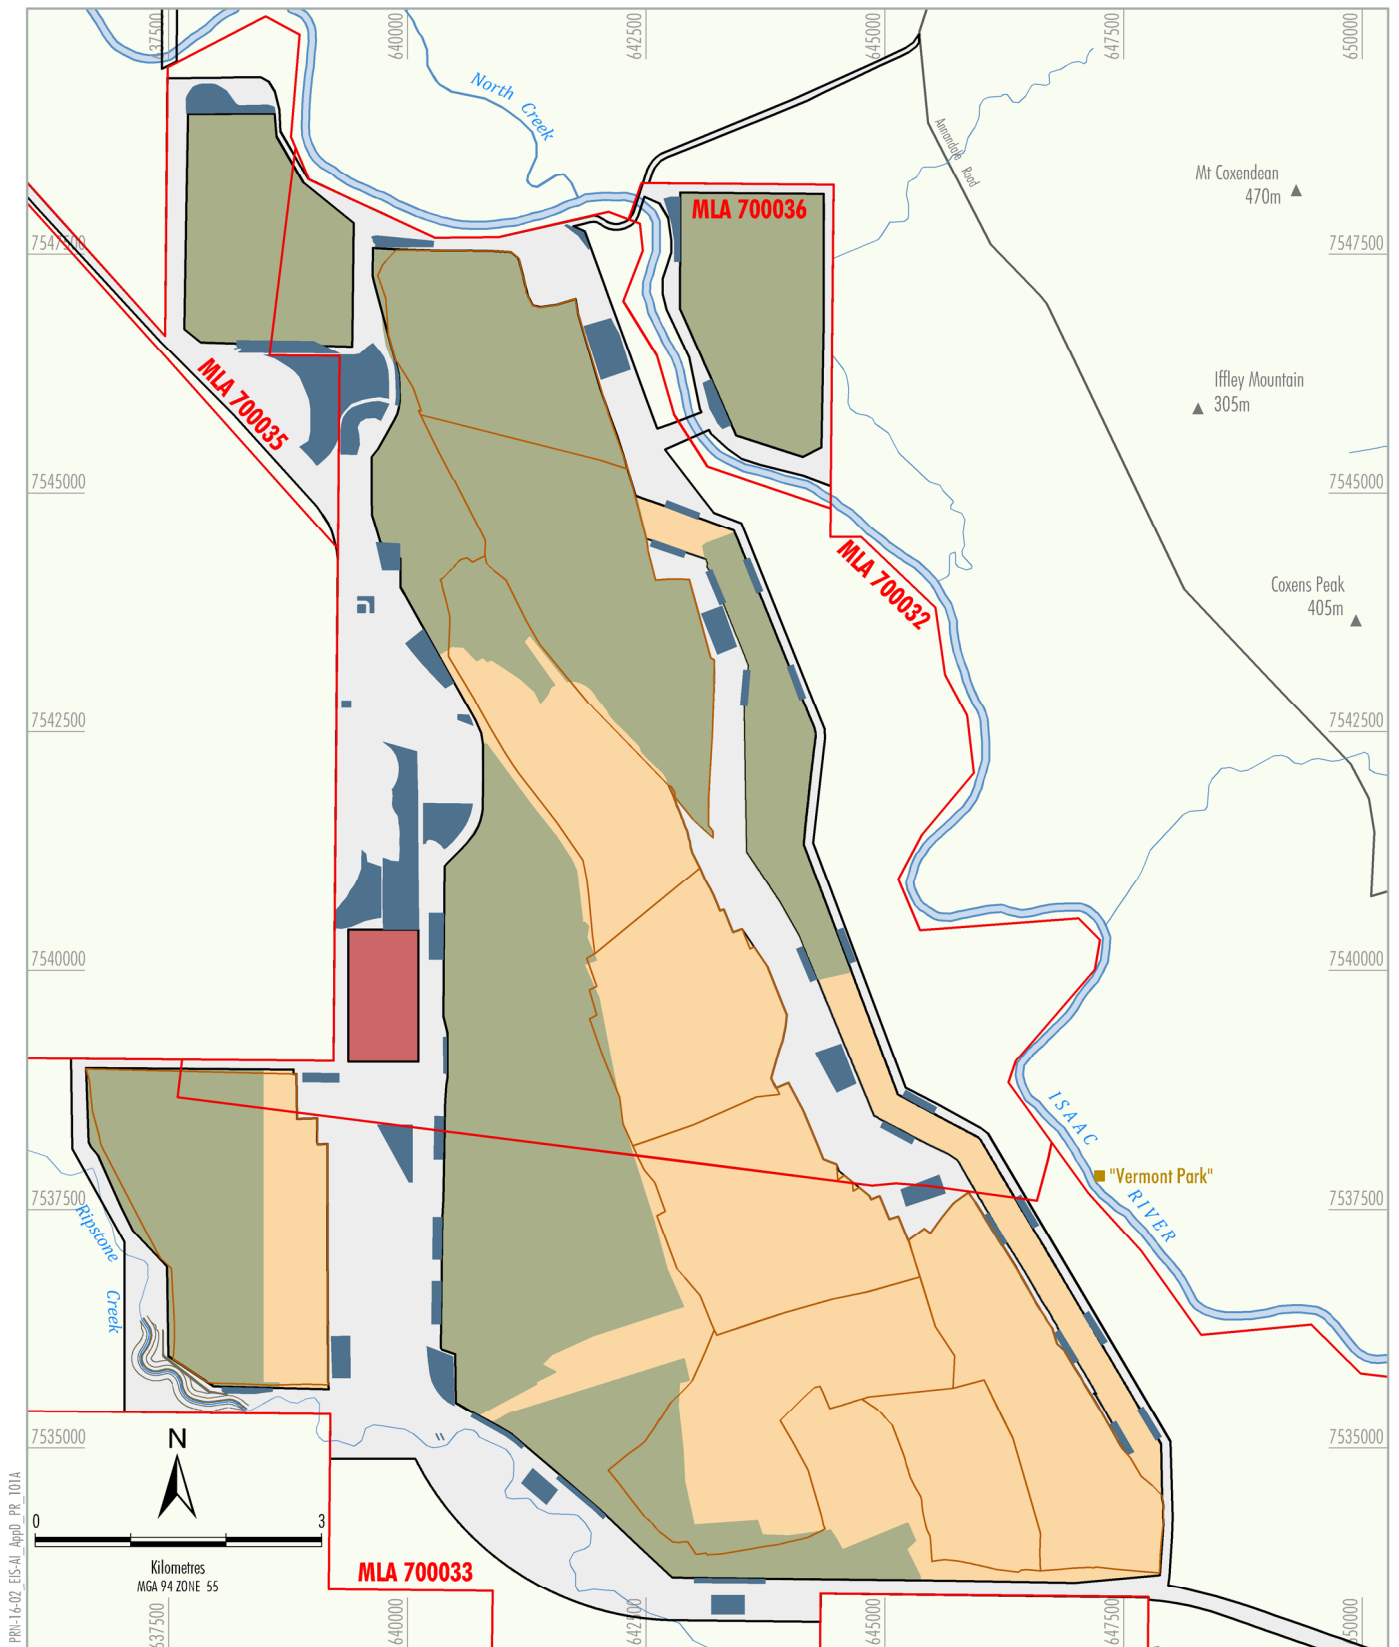
Figure 6

**PEMBROKE**
OLIVE DOWNS COKING COAL PROJECT
Olive Downs South Domain
Progressive Rehabilitation - 2050
