Olive Downs Coking Coal Project

Additional Information to the
Environmental Impact Statement

**Additional Information on
the Rehabilitation Strategy**

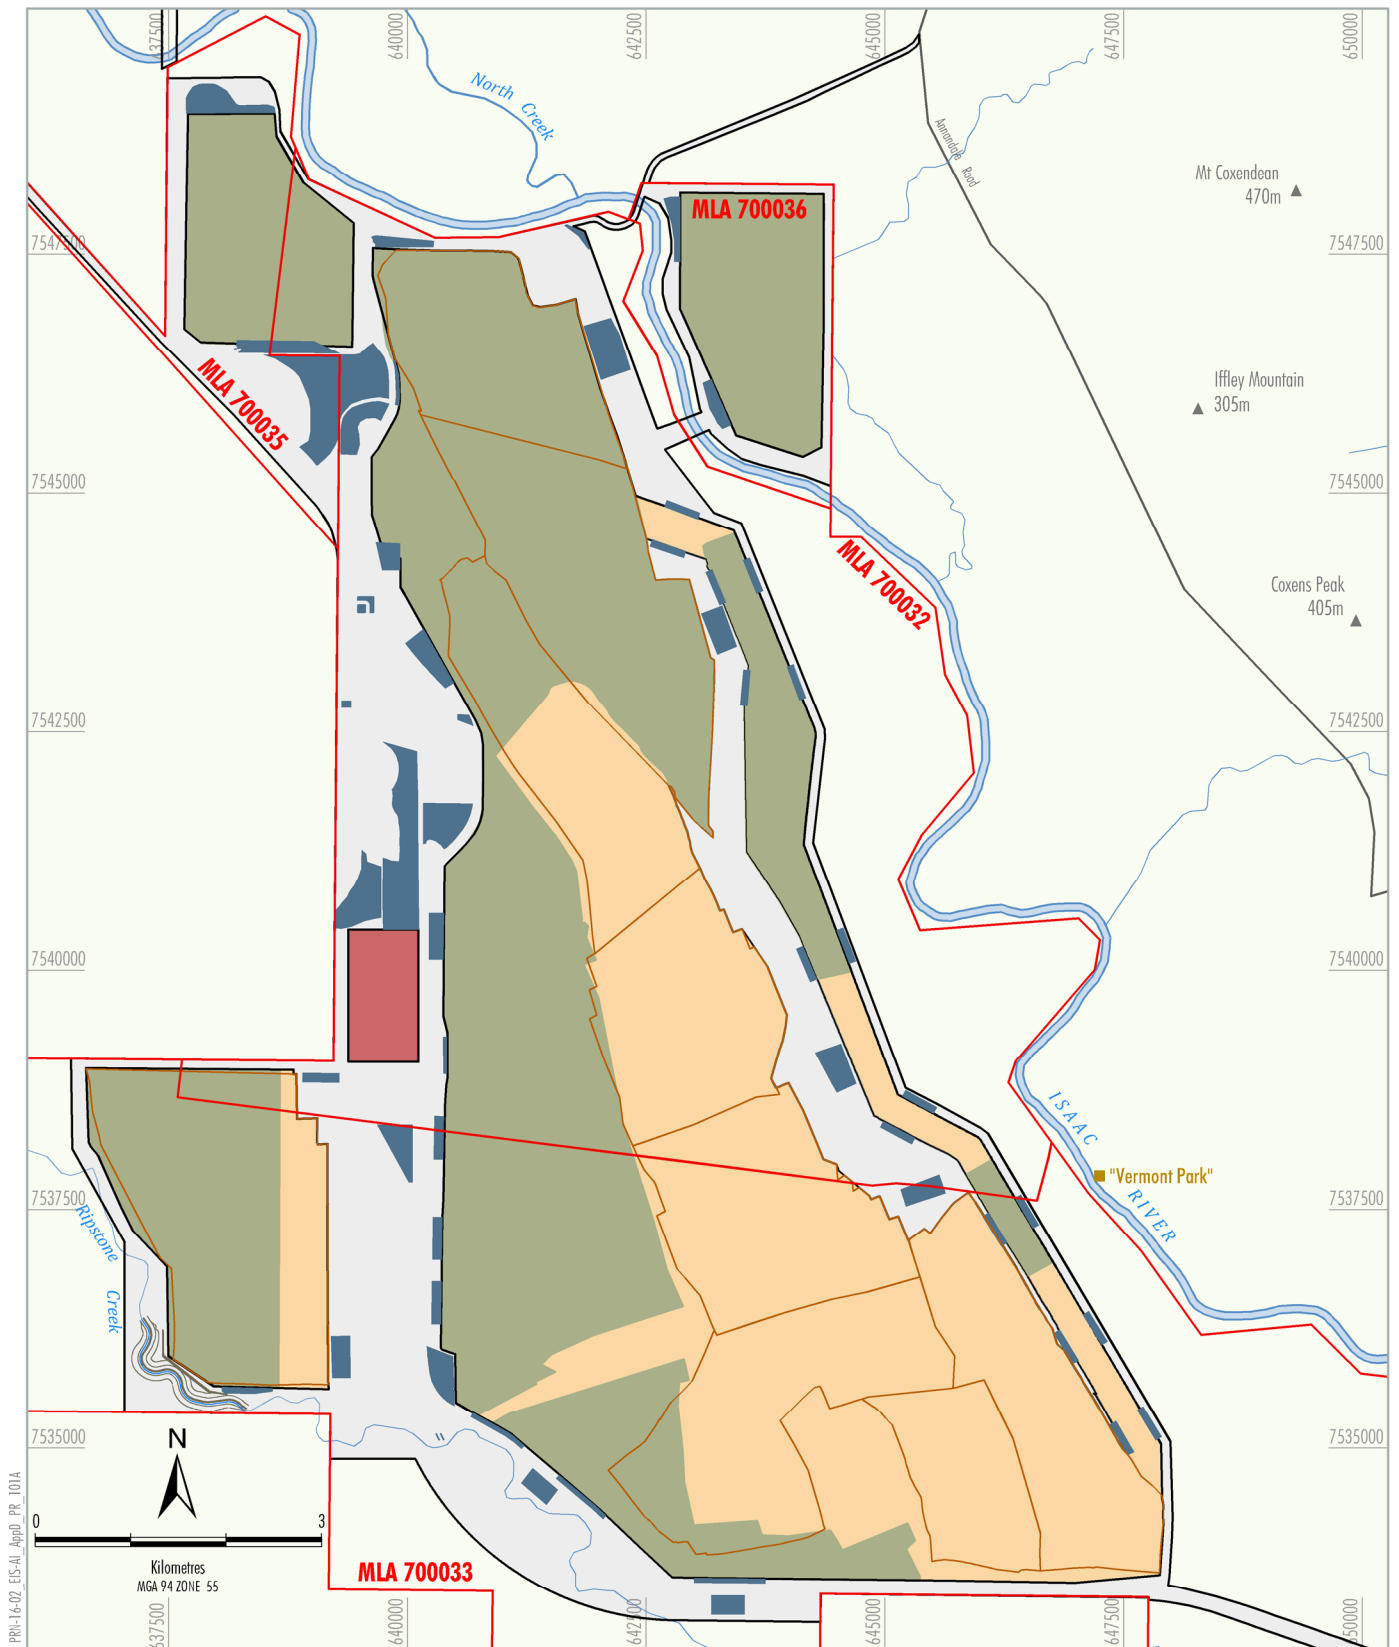
Figure 7

OLIVE DOWNS COKING COAL PROJECT
Olive Downs South Domain
Progressive Rehabilitation - 2055

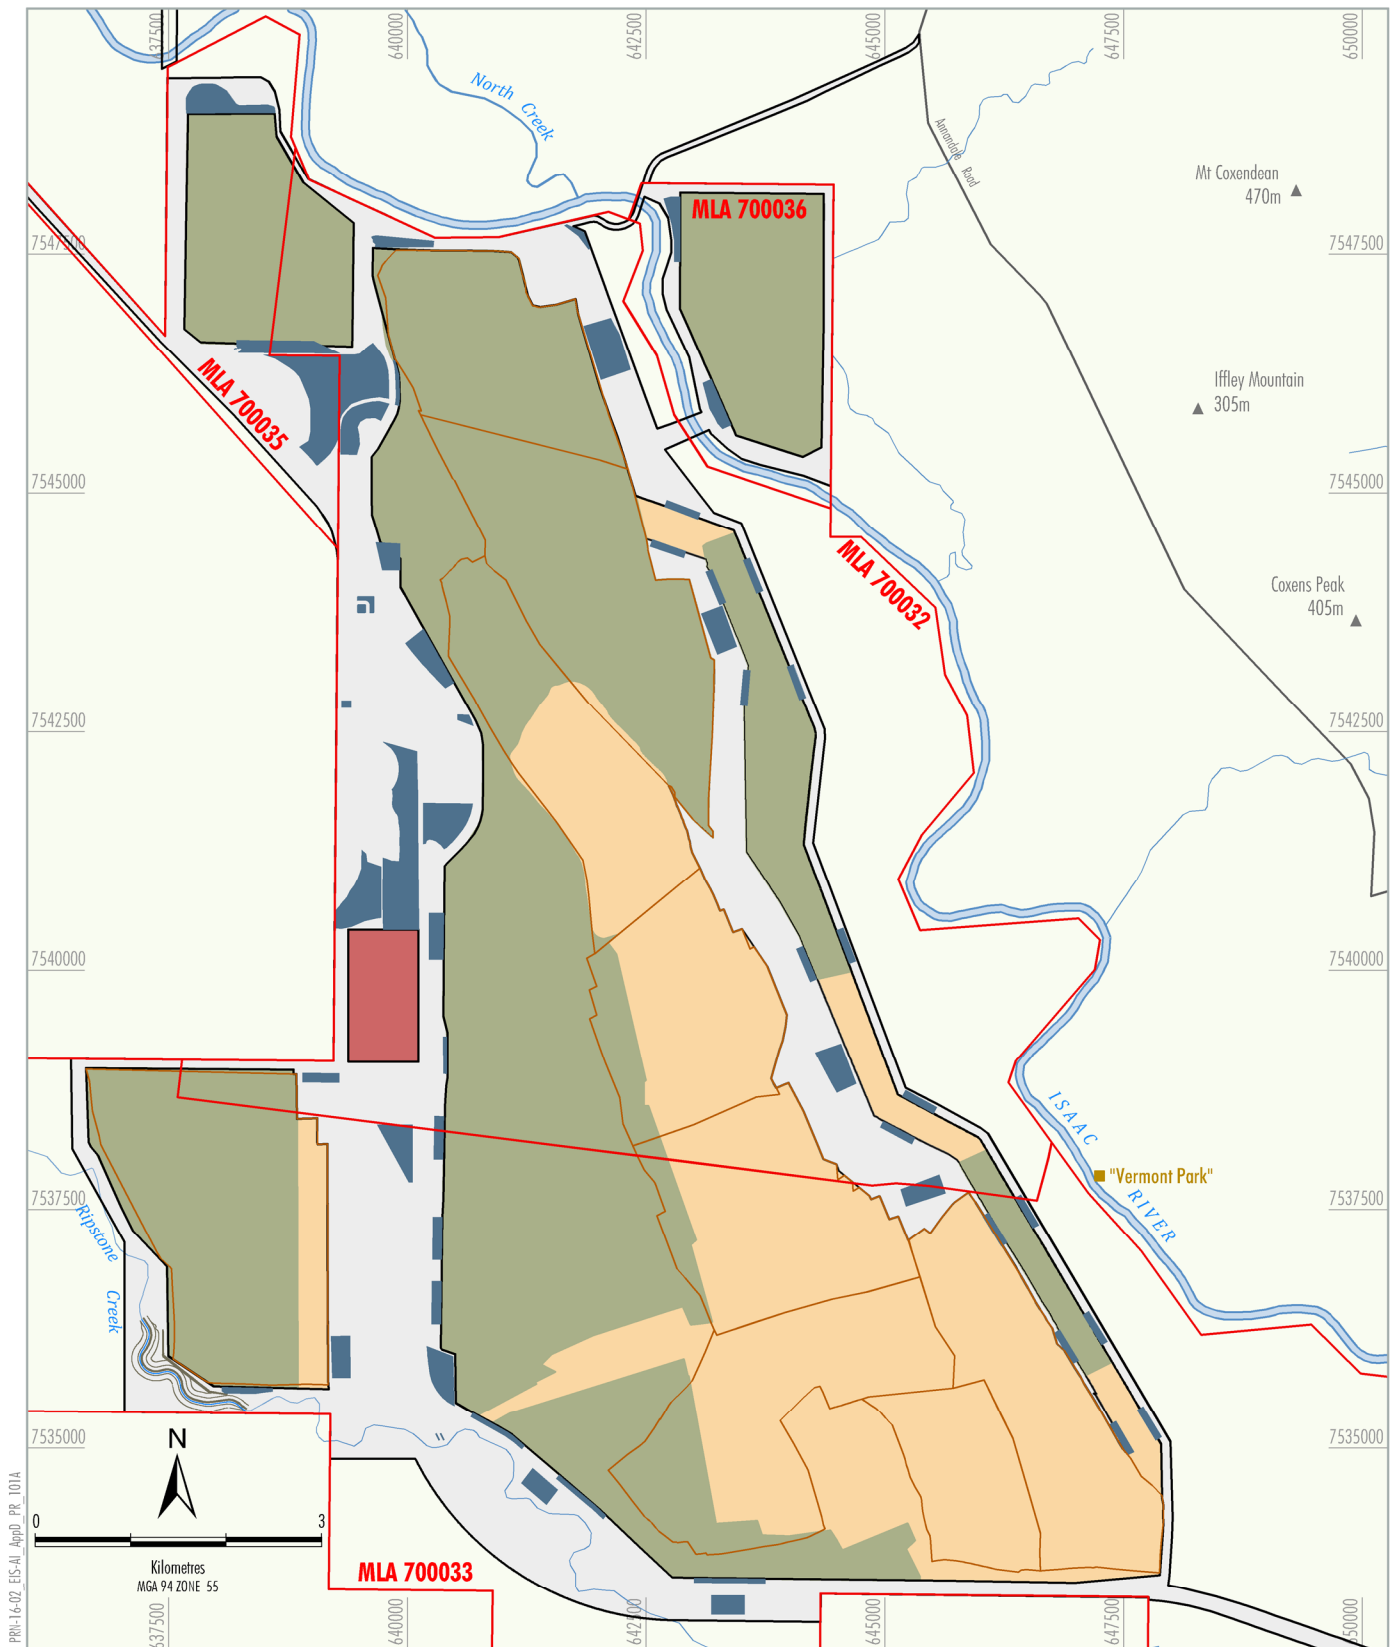
Figure 8

PEMBROKE
 OLIVE DOWNS COKING COAL PROJECT
 Olive Downs South Domain
 Progressive Rehabilitation - 2060

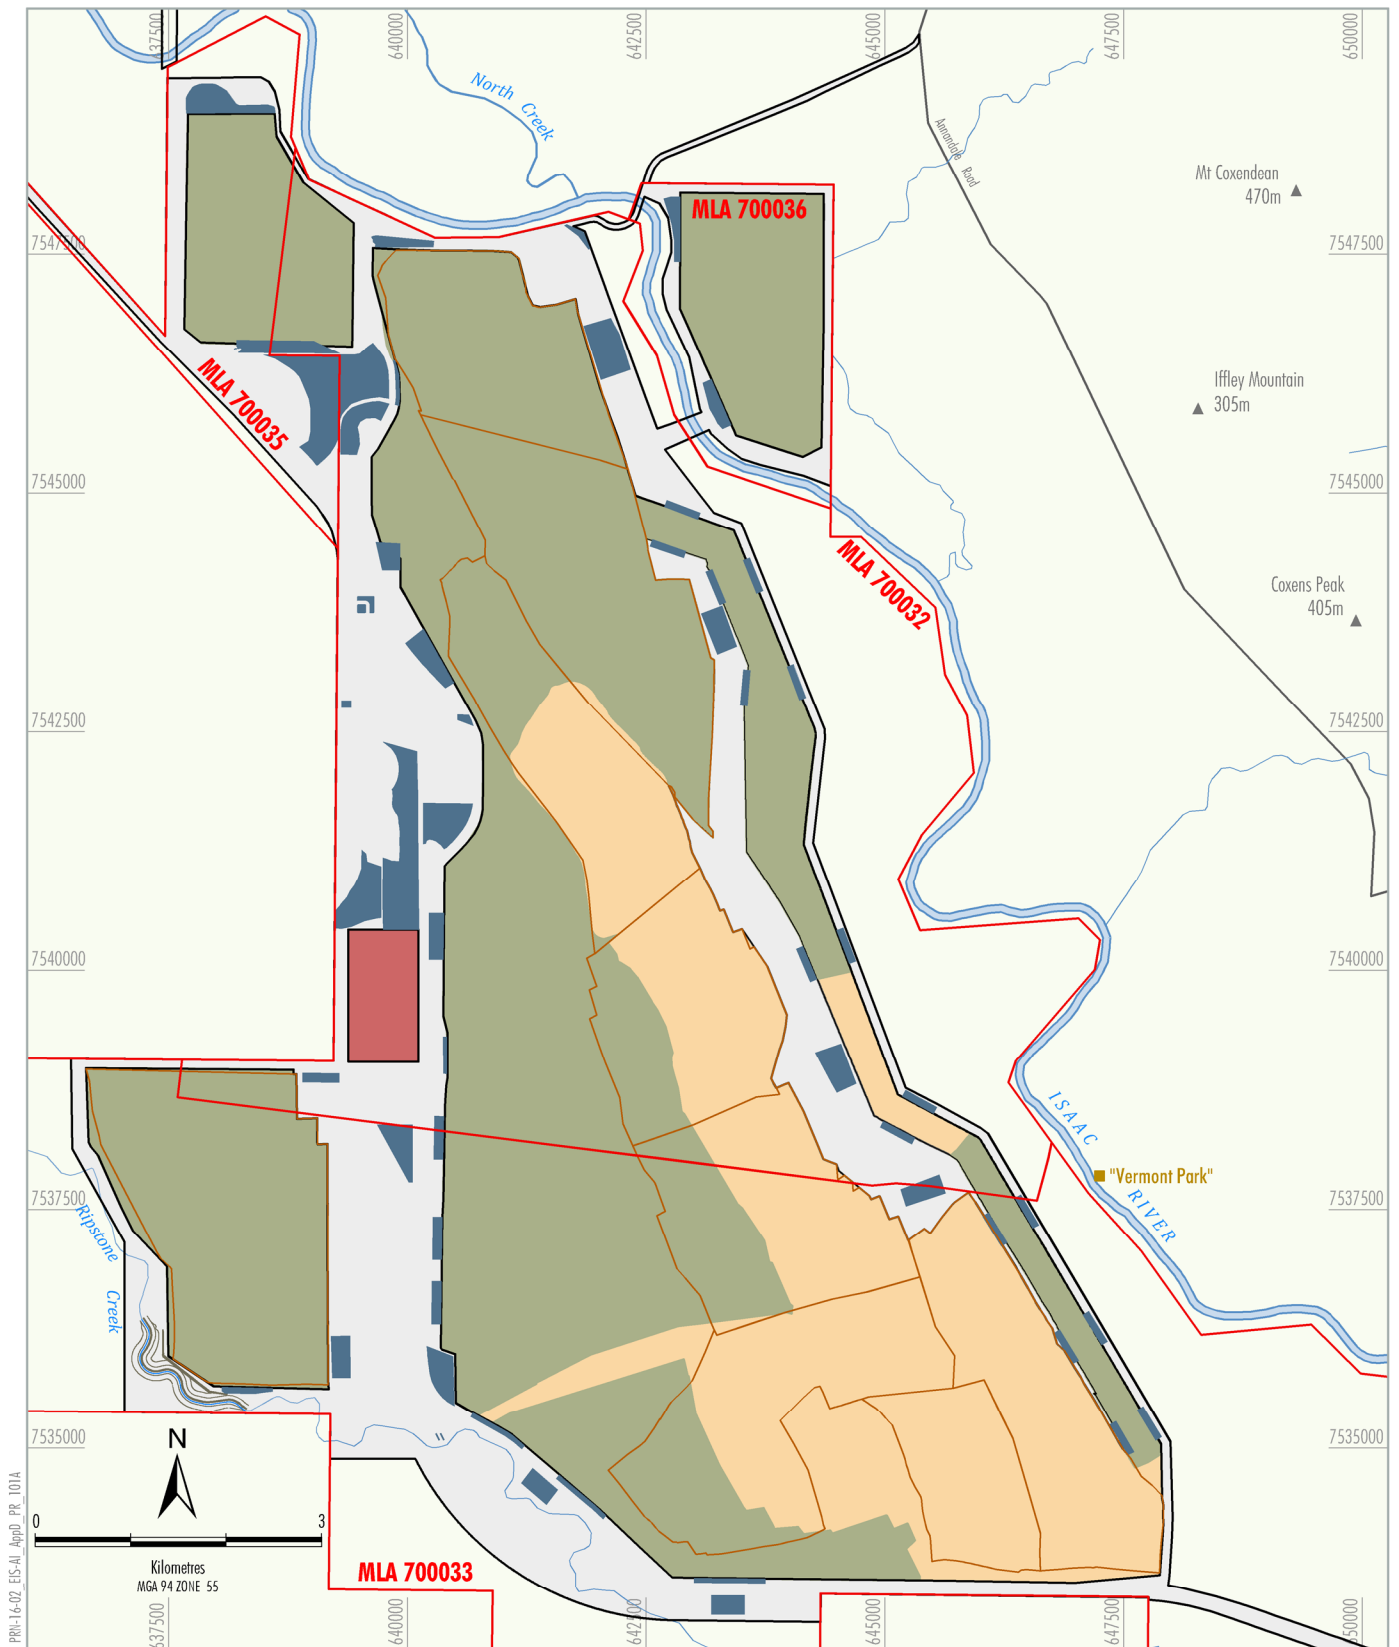
Figure 9

PEMBROKE
 OLIVE DOWNS COKING COAL PROJECT
 Olive Downs South Domain
 Progressive Rehabilitation - 2065
