**Olive Downs Coking Coal Project**

Additional Information to the  
Environmental Impact Statement

**Section 4**

**Rehabilitation**

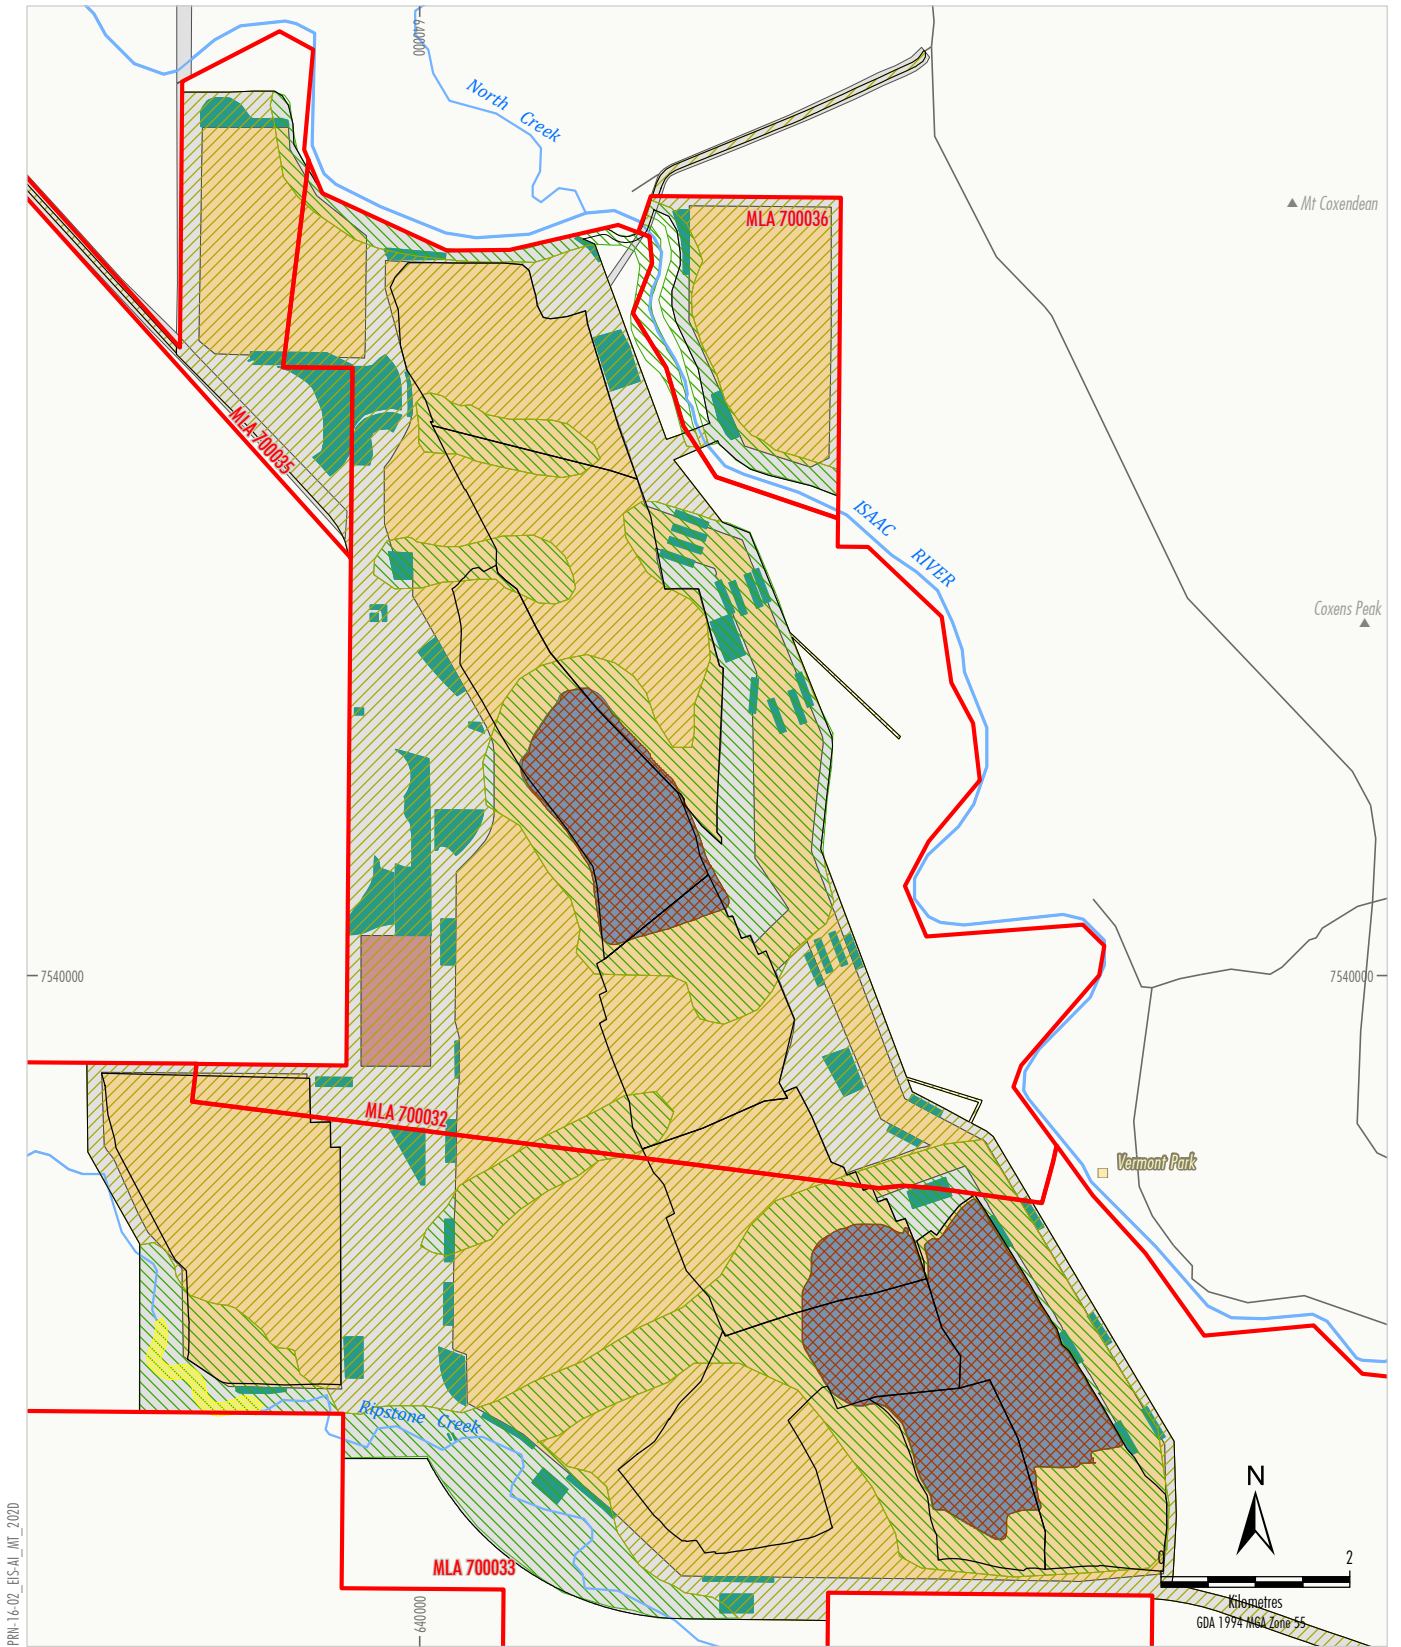
Figure 4-1a

OLIVE DOWNS COKING COAL PROJECT  
 Conceptual Post-mining Land Use  
 Olive Downs South Domain

Table 4-1 lists the proposed post-mining land uses for each rehabilitation domain. Figures 4-1a and 4-1b shows the proposed post-mining land uses and rehabilitation domains.

A new rehabilitation domain for the Ripstone Creek diversion has been added to the existing Project rehabilitation domains. The revised Project rehabilitation domains are described in Table 4-1 and shown on Figures 4-1a and 4-1b.

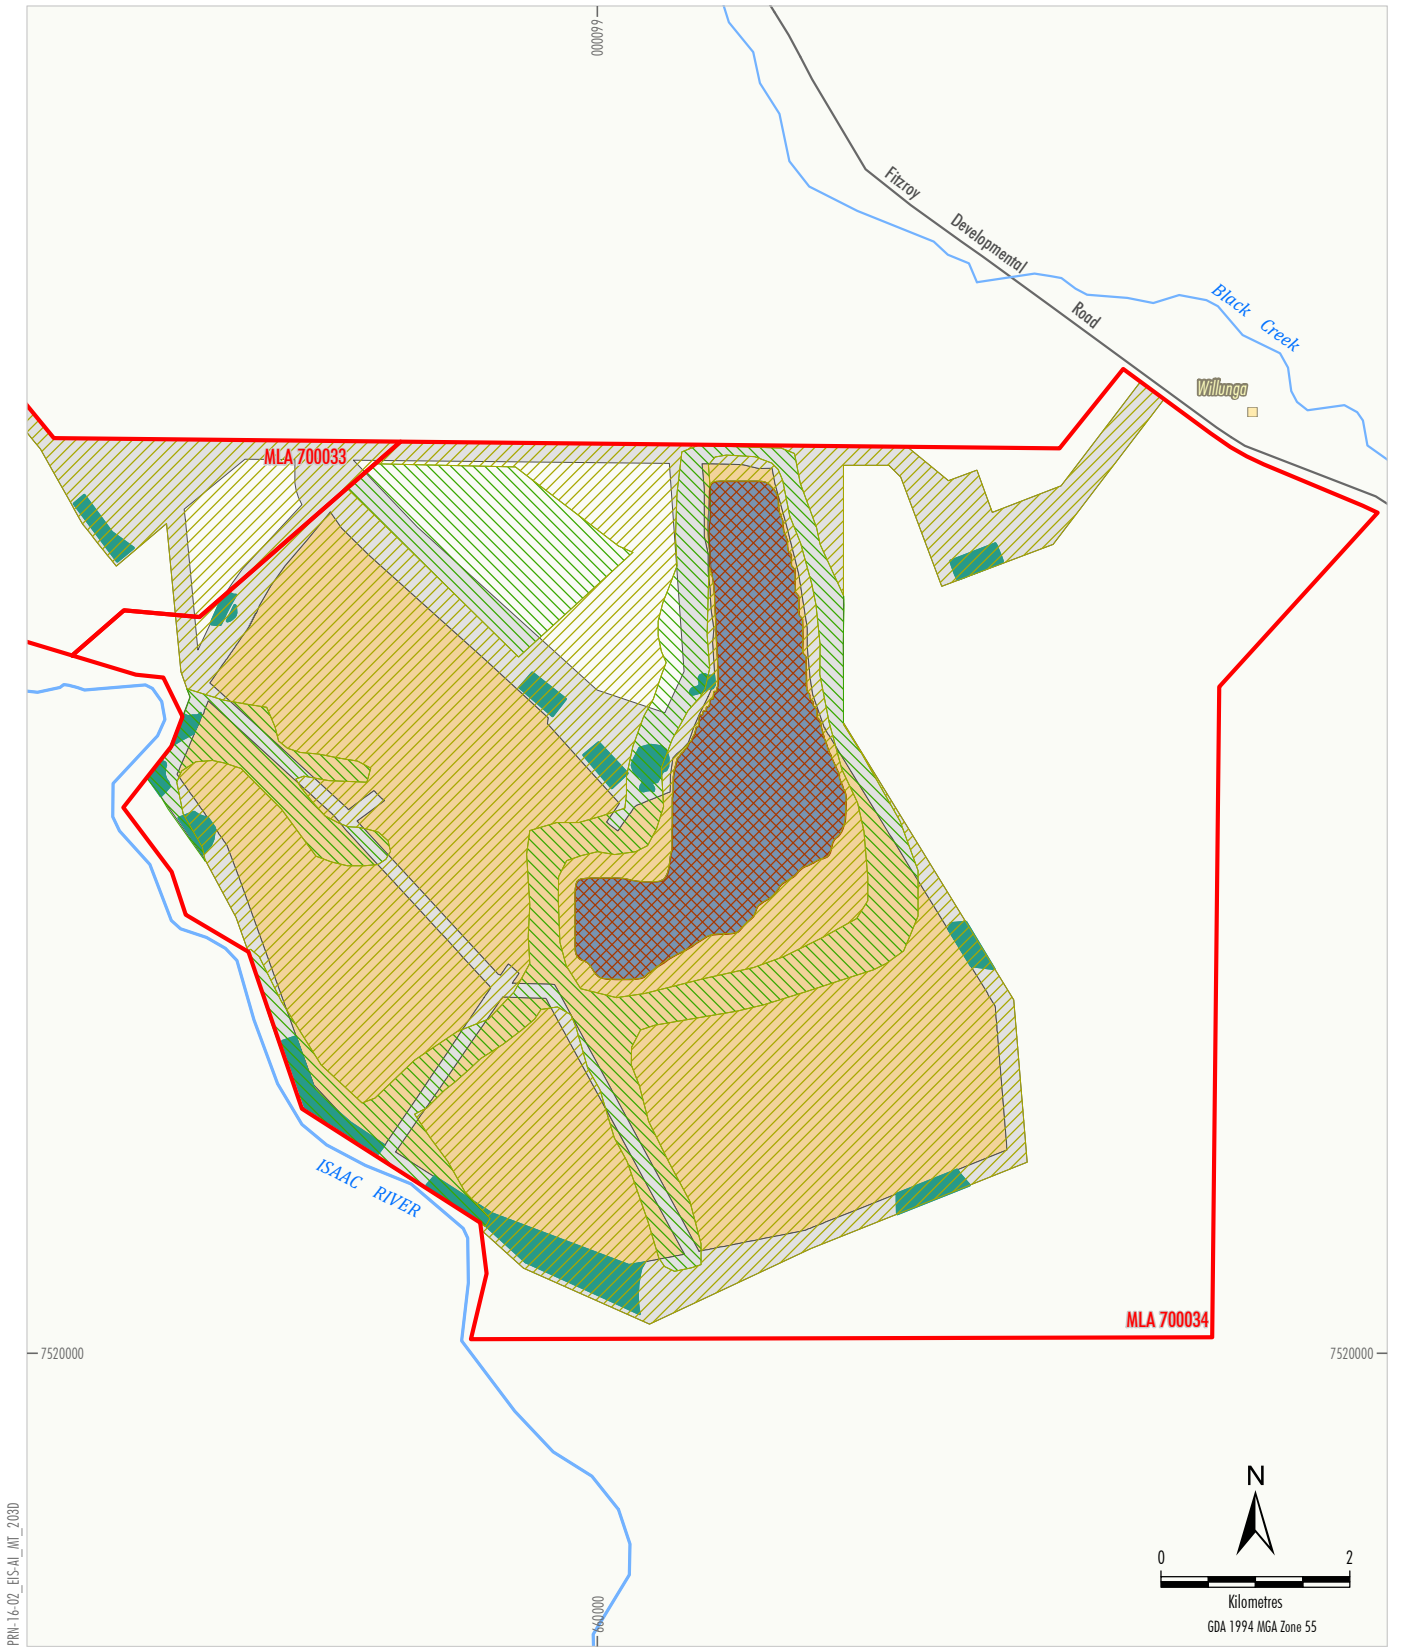
Figure 4-1b

OLIVE DOWNS COKING COAL PROJECT  
 Conceptual Post-mining Land Use  
 Willunga Domain
